# Modified Completion Report Monitoring

Draft Analysis 2005

# **Modified Completion Report Monitoring 2001 to 2004**

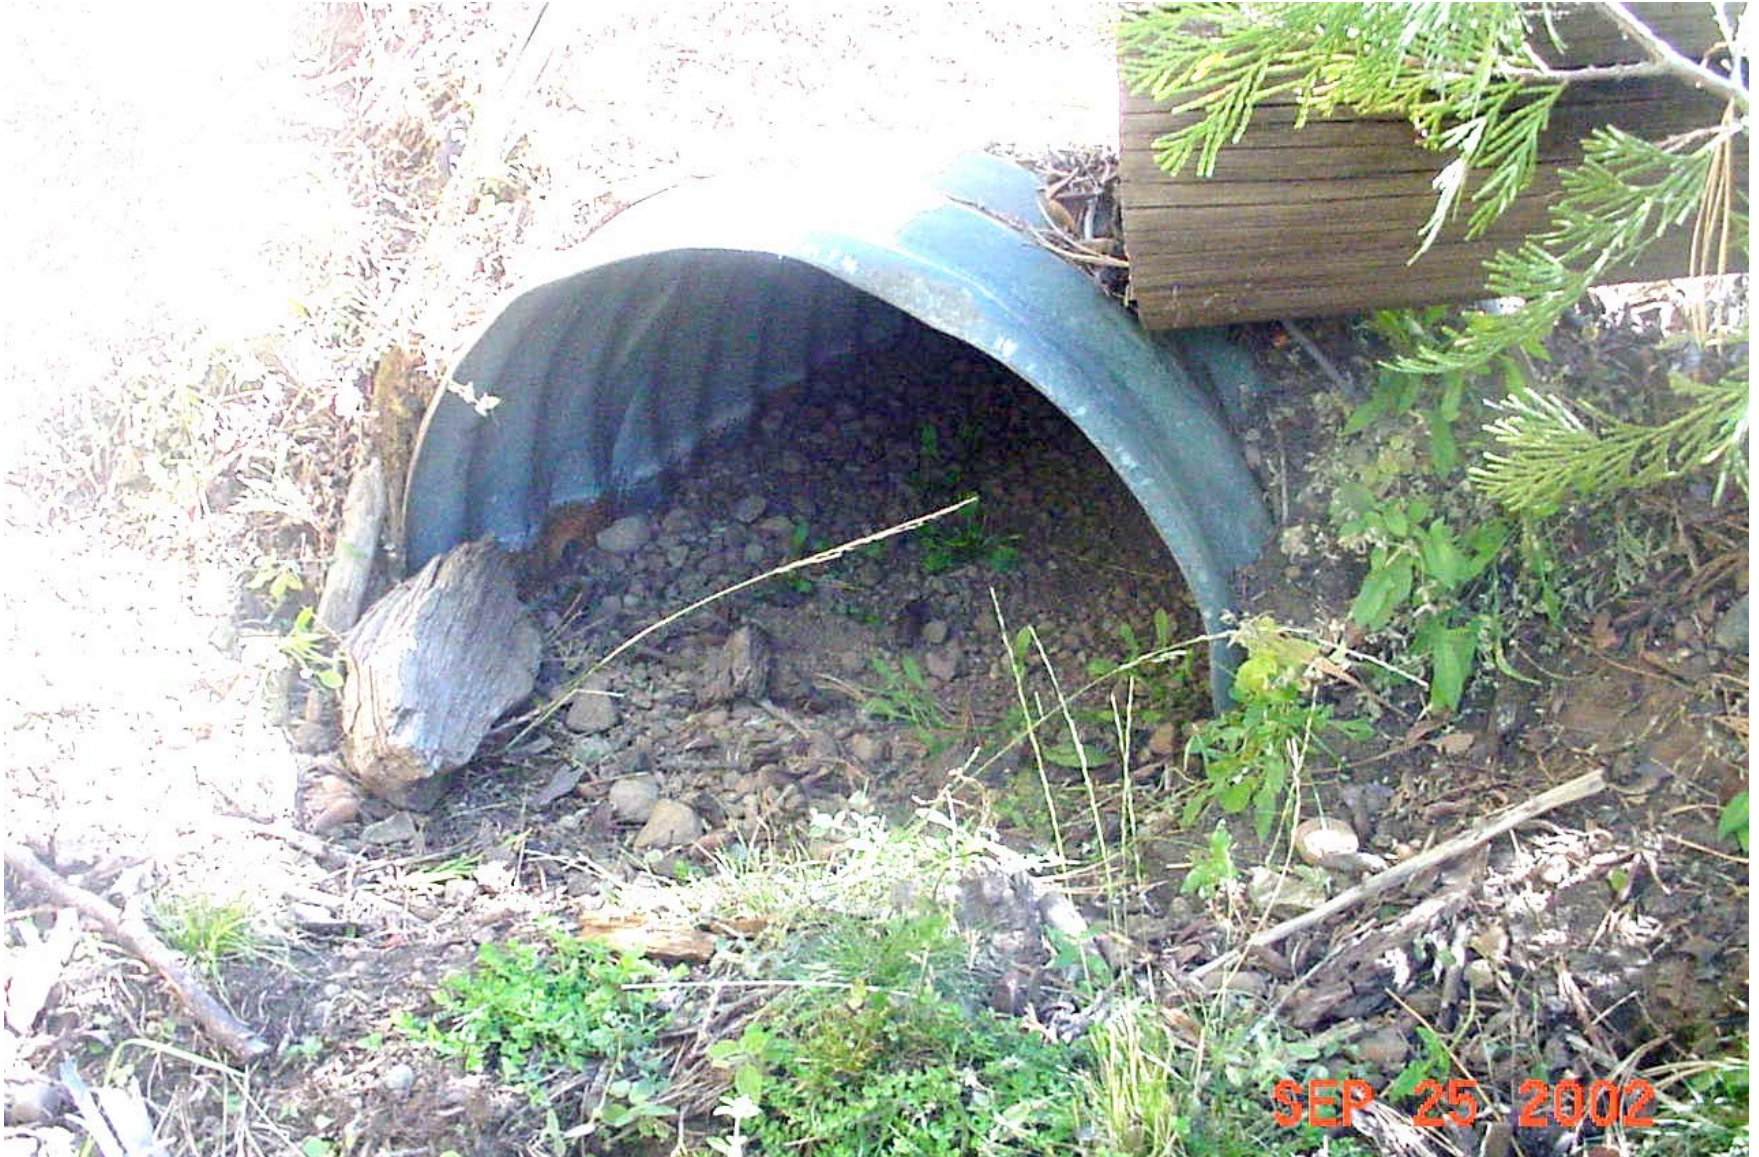
# Culvert with Sediment Plugging

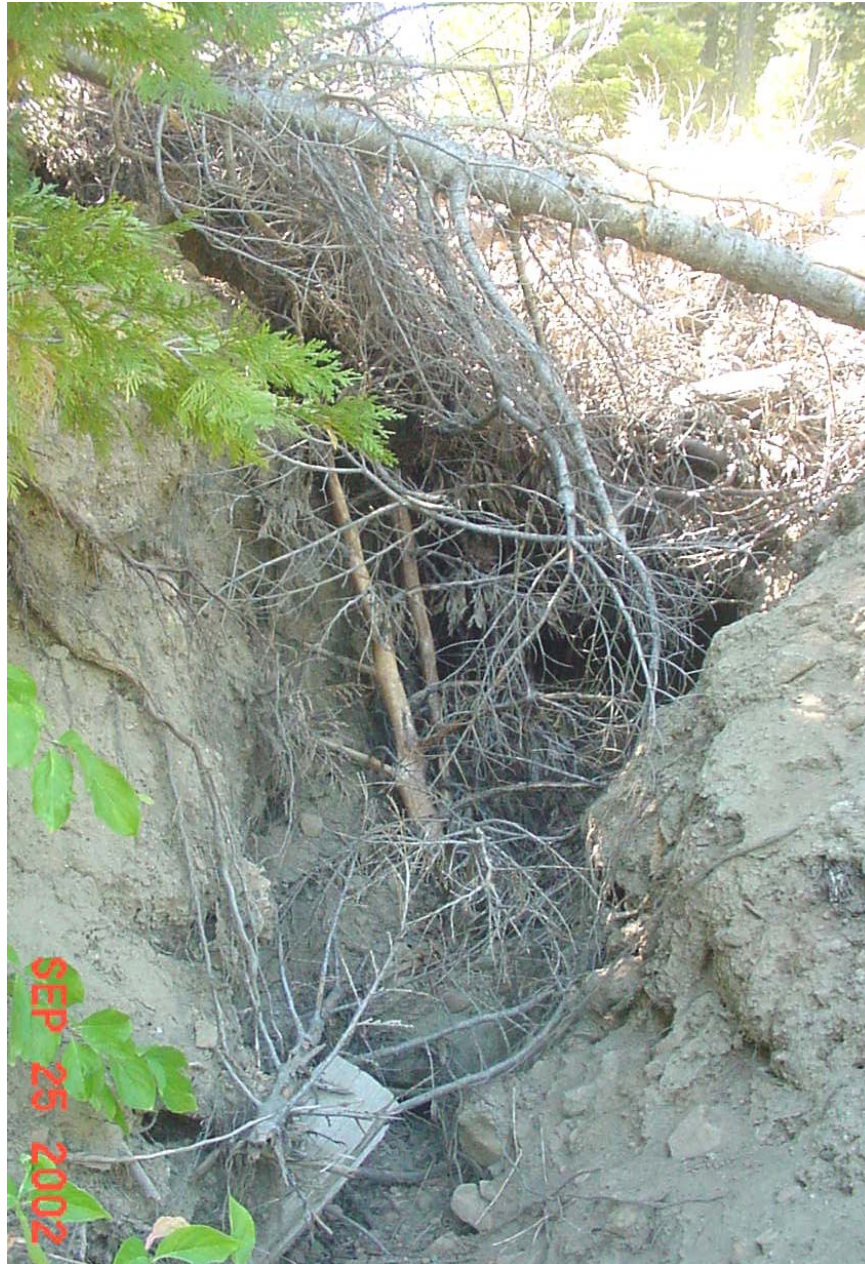
# Gully from Diversion below Culvert

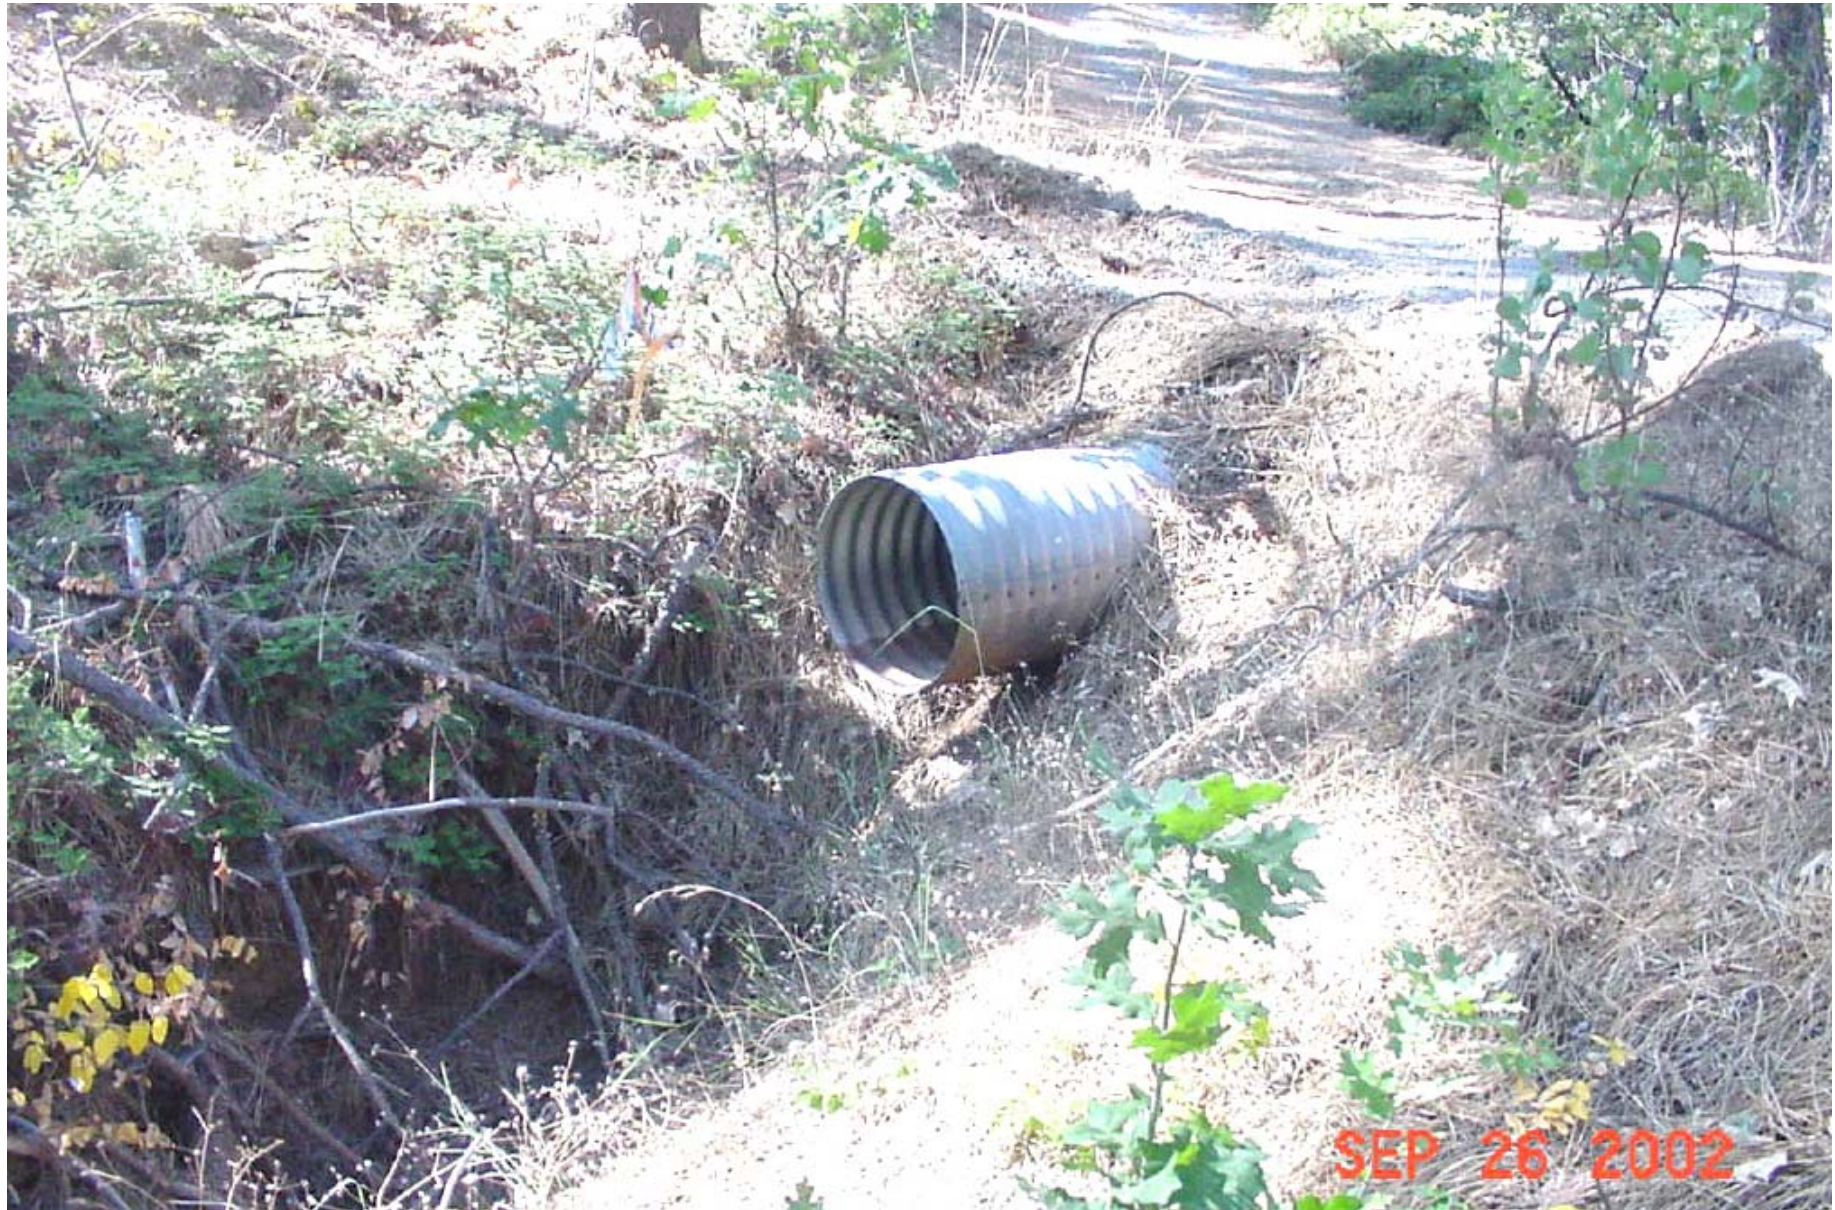
# Culvert with Scour at the Outlet

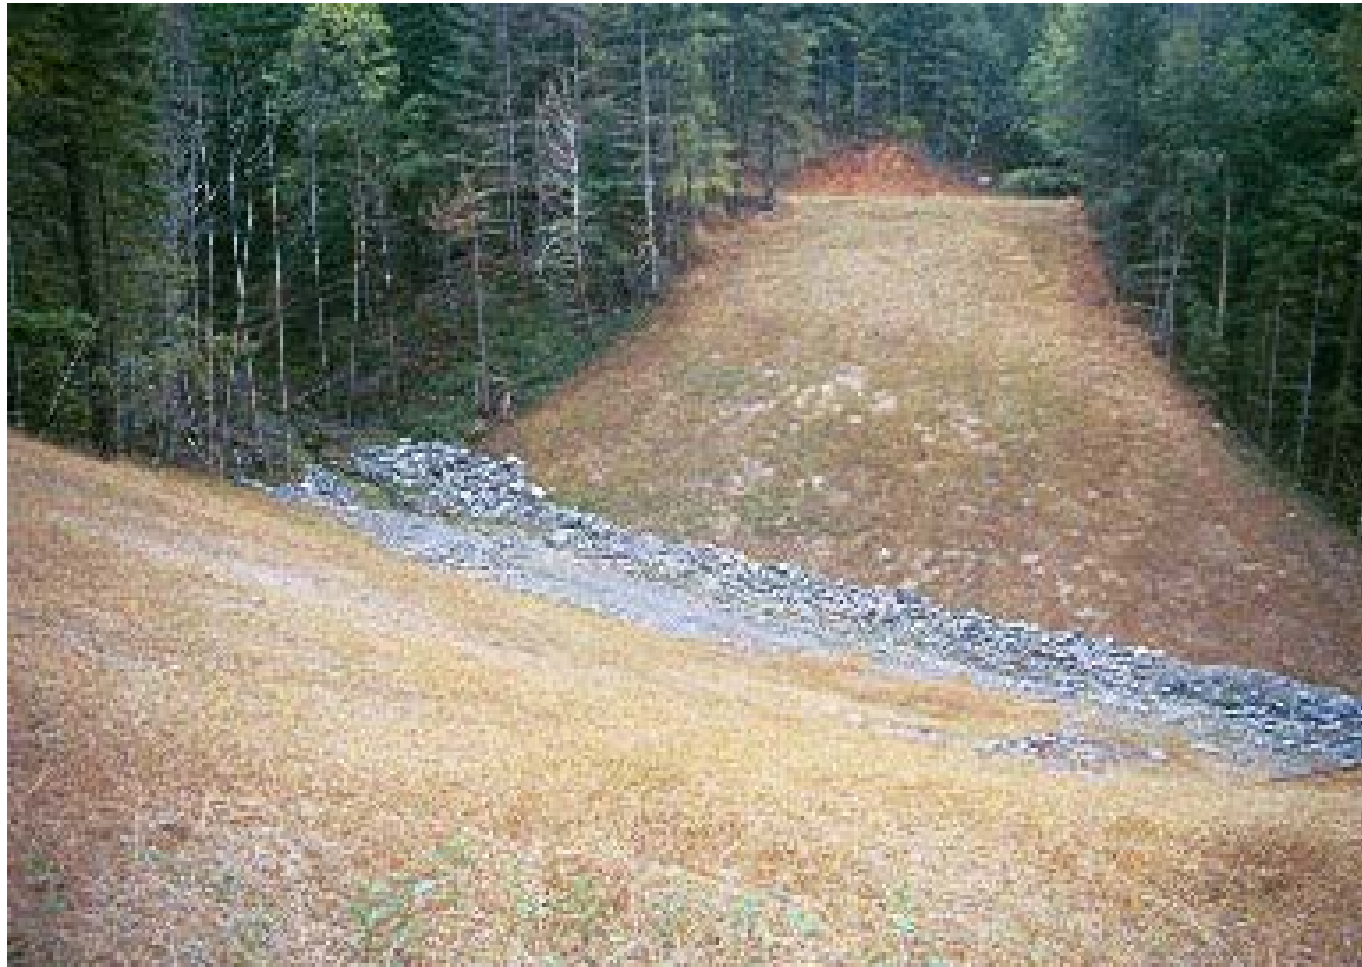
# Abandoned/Removed: Channel Configuration
